STREAM CHANNEL POST-RESTORATION MONITORING OF THE SOQUE RIVER, GEORGIA

REFERENCE: *Proceedings of the 2001 Georgia Water Resources Conference*, held March 26-27, 2001, at the University of Georgia. Kathryn J. Hatcher, editor, Institute of Ecology, The University of Georgia, Athens, Georgia.

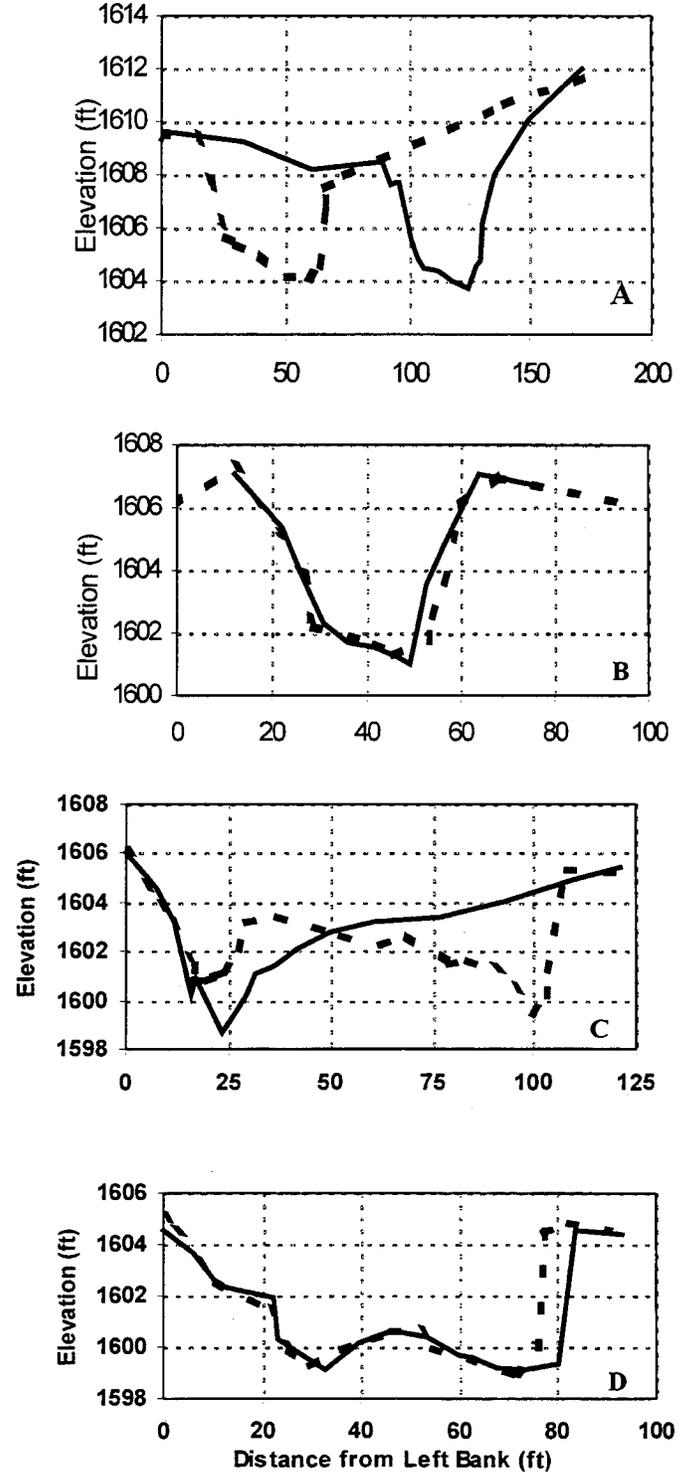
Four channel cross-sections (XS) were surveyed pre- (April to June 1998) and post-restoration (December 2000) to aid in the restoration design and to monitor the success of the project, respectively (Figure 1, A-D). Station LFS10 (location 1+94) was located at the reconstructed meander as graphically depicted in Figure 1A. LFS50 (7+09) was located along an unrestored, but stable, section of the existing channel. LFS60 (9+60) was located across a multi-channel reach that exhibited extreme bank failure on the right bank as depicted in Figure 1C. LFS70 (12+39) was located immediately downstream of the restoration project, and consequently was in a segment considered unaffected by the restoration. Thus, station LFS 70 was representative of pre-restoration conditions of the stream. Bankfull (return interval 1-2 years) measurements included average depth (D_{bkf}), width (W_{bkf}), and cross-sectional area (A_{bkf}). In addition, bankfull width to depth ratios (W/D) were calculated.

D_{bkf} increased at stations LFS10, LFS50 and LFS 60. However, the most dramatic increase in D_{bkf} was observed within one of the reconstructed channels at LFS60, where it more than doubled (0.8 to 1.8 ft). W_{bkf} decreased at all XS with the exception of LFS70 where it increased from 47 to 54 feet. The loss of approximately four feet of bank material from the right bank contributed to the increase in W_{bkf} at LFS70 (Figure 1D). A_{bkf} increased at all XS with the exception of LFS50. W/D ratios decreased at stations LFS10, LFS50 and LFS60 and increased at LFS70. However, the largest changes were observed within the reconstructed channels at LFS10 (where W/D decreased from 29 to 21) and LFS60 (50 to 17). W/D increased slightly at LFS 70, immediately downstream of the restored reach, from 65 to 69.

Figure 1. Left Fork Soque River Cross-Sections (Broken Line = Pre-Construction, April-June 1998, Solid Line = Post-Construction, Dec. 2000; A = LFS10, B = LFS50, C = LFS60, D = LFS70; Vertical Axis Exaggerated)
