EVALUATION OF A BTEX PLUME IN FRACTURED CRYSTALLINE ROCK IN THE GEORGIA PIEDMONT

James B. Feild¹ and John F. Dowd²

REFERENCE: *Proceedings of the 1999 Georgia Water Resources Conference*, held March 30-31, 1999, at the University of Georgia. Kathryn J. Hatcher, editor, Institute Ecology, The University of Georgia, Athens, Georgia.

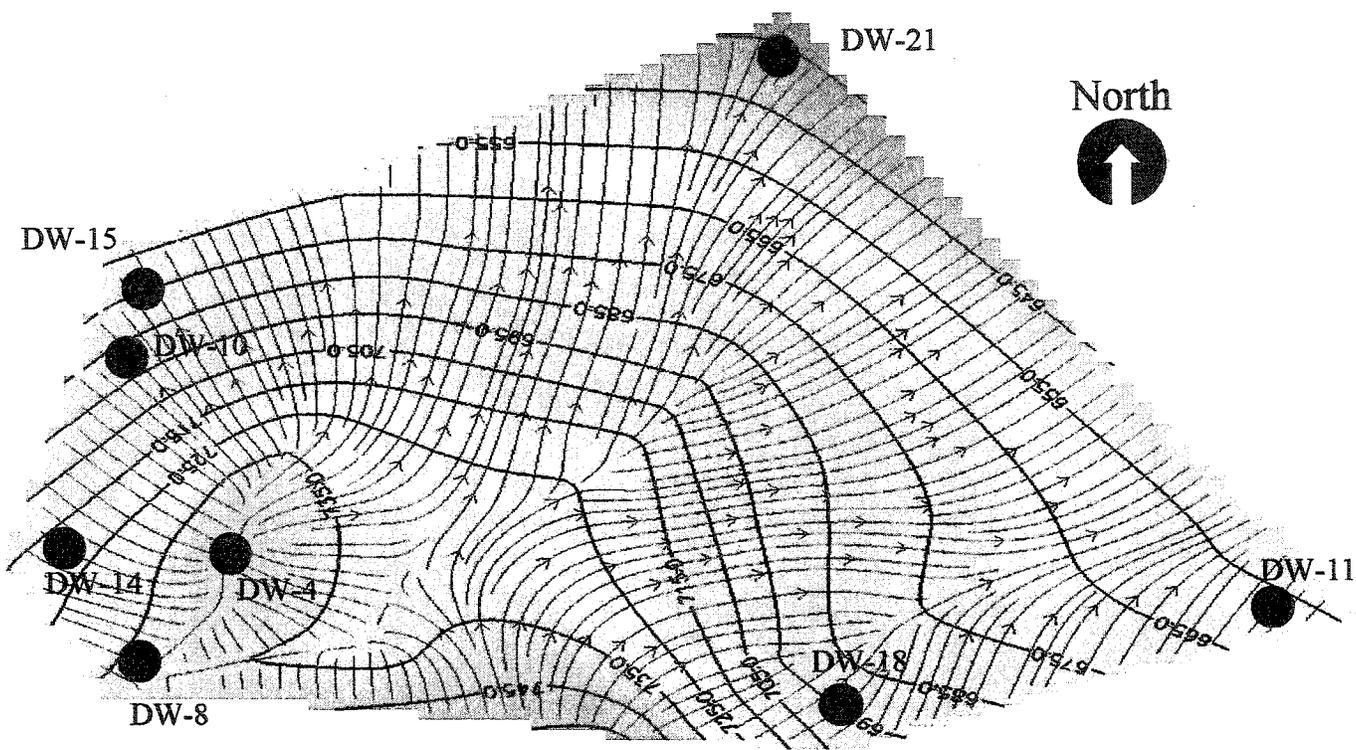
Figure 2. Bedrock groundwater elevations and groundwater contours on May 25, 1998.

As can be seen from Figure 2, the groundwater elevations and contours of the fractured bedrock aquifer show that the local maximum or high point is located at well DW-4. Monitoring well DW-4 is located directly below the location of the known chemical spills. The streamlines (directional arrows) illustrate that the groundwater flow is divergent or flowing away from DW-4 in all directions. There exists in the area of DW-4 a groundwater remediation system which consists of a recovery well and an air stripping tower.

From inspection of the groundwater elevations and contours (figure 2), it is clear that the remediation system has no effect upon the fractured bedrock aquifer. If the remediation system was affecting the bedrock aquifer, this would be apparent from the drawdown of the bedrock aquifer in the vicinity of the site (DW-4). A cone of

depression in the surface of the groundwater would be evident surrounding the site. Since Figure 2 shows a groundwater elevation high or mound in the vicinity of the site (DW-4), it is assumed that the remediation system is not influencing the bedrock aquifer at all.

aquifer (see figures 2, 3, 4 and 5). This is because the recovery well is open to both the saprolite and the bedrock, and the recovery well is preferentially recovering water from the saprolite. The well should be abandoned and two separate wells should be used to treat the bedrock and the saprolite. This design will prevent further migration of contaminants from the saprolite aquifer to the bedrock aquifer, and will also increase the efficiency of the remediation system.

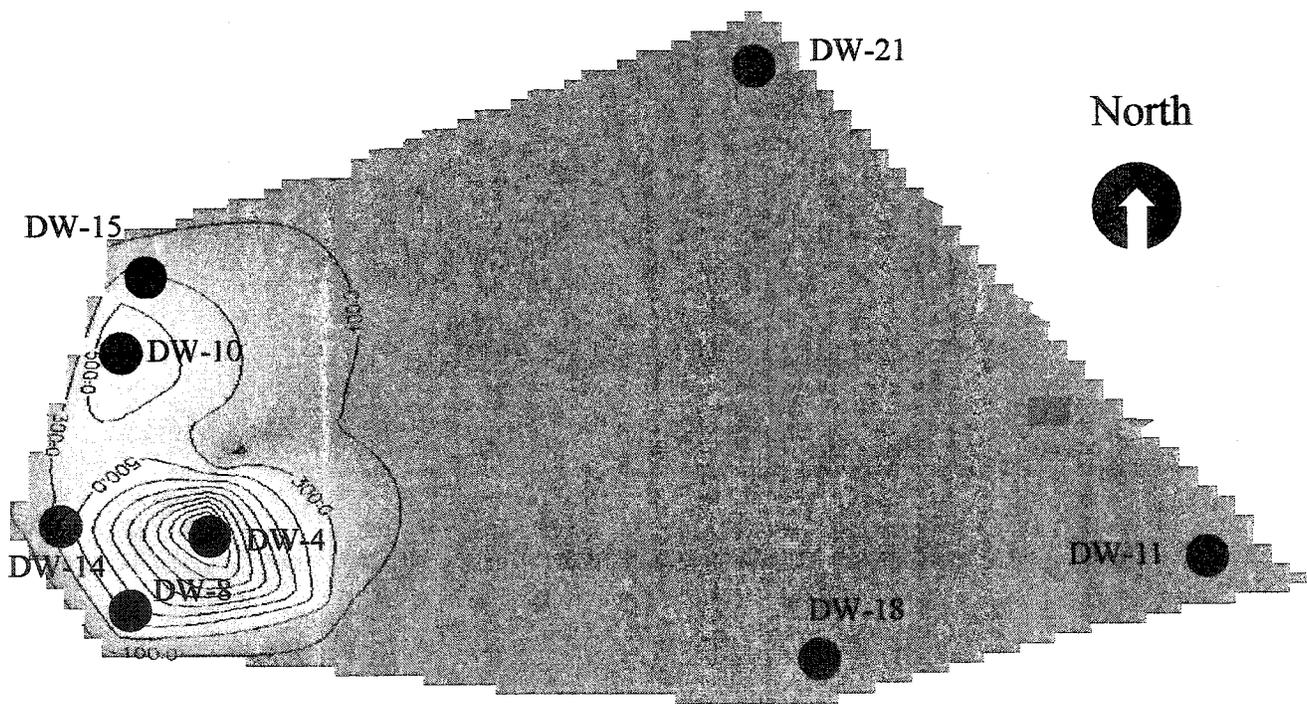
Figure 3. Bedrock benzene concentrations and benzene contours on May 27, 1998.

Figure 3 shows the benzene concentration of samples collected from the fractured bedrock wells. The figure shows two distinct areas of contaminated groundwater within the bedrock aquifer (DW-4 and DW-10). Samples from DW-4 and DW-10 were found to contain approximately 2500 and 800 ppb of benzene, respectively.

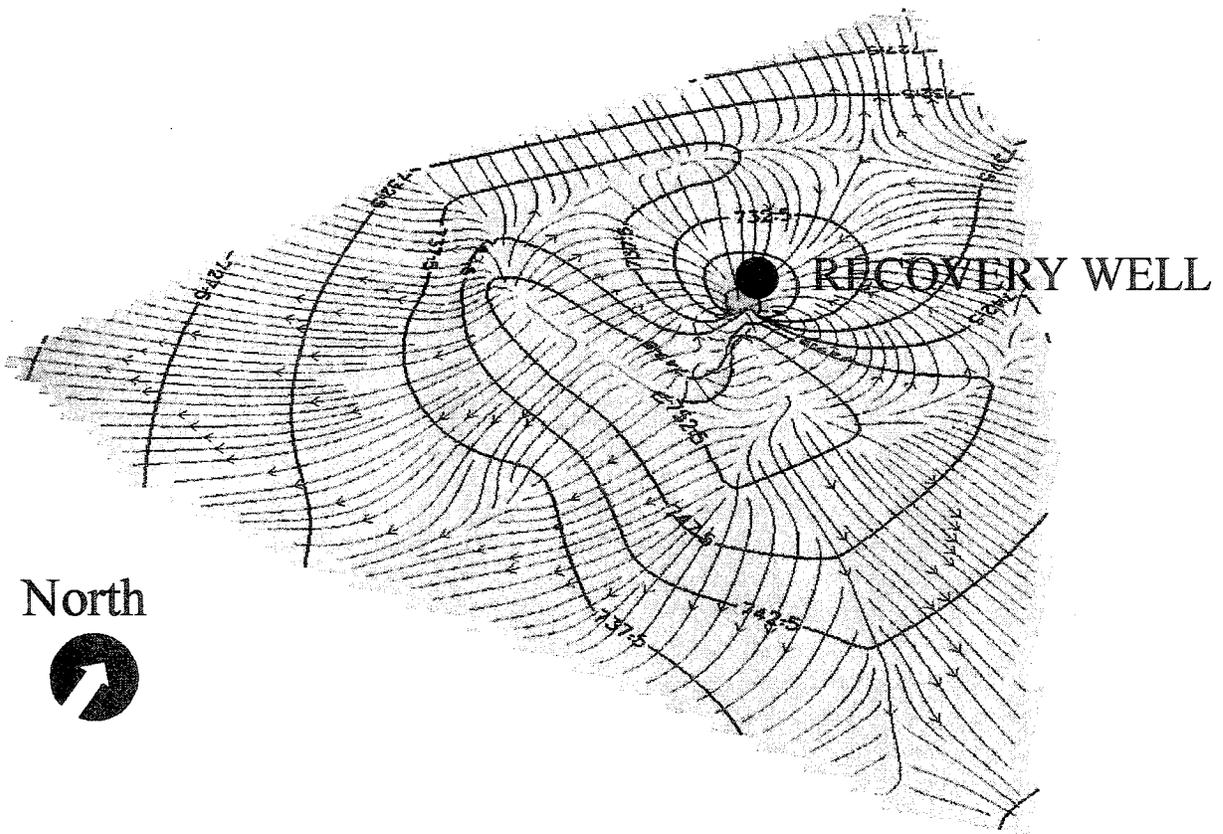
Figure 4. Groundwater Elevations Contours and Flowlines for Saprolite Aquifer. November 28, 1997

Figure 4 and 5 illustrate, for the purposes of comparison, a groundwater elevation and contour map, and a benzene concentration for the saprolite aquifer. The figures show the small cone of depression around the recovery well created by the remediation system. The cone of depression is characterized by steep gradients, but it does not completely capture the benzene plume in the saprolite aquifer.
