FLOODS IN CENTRAL AND SOUTHWESTERN GEORGIA IN JULY 1994

Timothy C. Stamey

REFERENCE: *Proceedings of the 1995 Georgia Water Resources Conference*, held April 11 and 12, 1995, at The University of Georgia, Kathryn J. Hatcher, Editor, Vinson Institute of Government, The University of Georgia, Athens, GA 30602-5482.

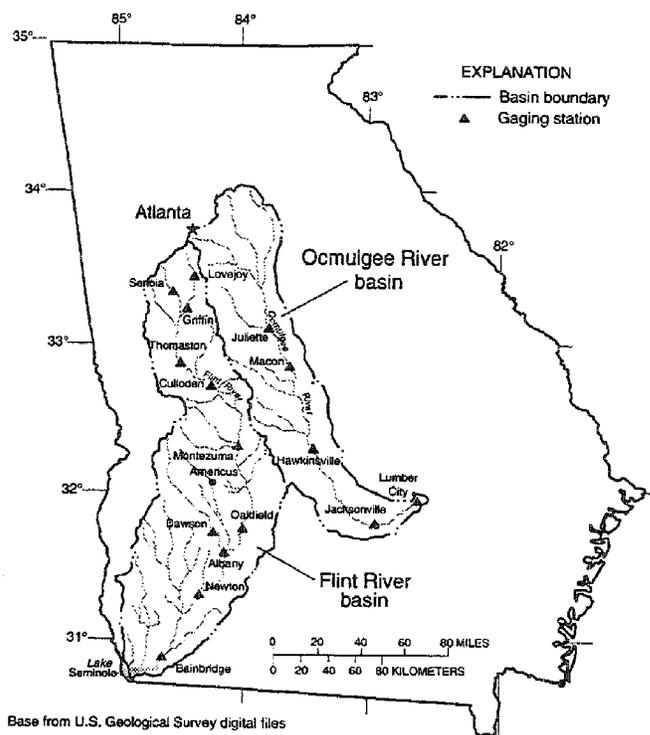
Figure 1. Location of Flint and Ocmulgee River basins and selected gaging stations affected by flooding, July 1994.

Stream flooding resulting from Tropical Storm Alberto was just as remarkable as the rainfall that caused the flooding. The most significant flooding in Georgia occurred along the Flint and Ocmulgee Rivers and their tributaries (fig. 1).

Peak discharges on the Ocmulgee River exceeded the 100-year flood discharge from near Juliette, about 25 miles north of Macon to Jacksonville, Ga. (fig. 1), to about 40 miles upstream from the confluence with the Oconee River (fig. 6). At Macon, the Ocmulgee River peaked on July 6 at a stage of about 35.4 ft, which was about 5.4 ft higher than the 1990 flood, and the highest stage since 1887. The highest peak discharge previously recorded at Macon was 83,500 ft³/s, which occurred during the 1948 flood. The 1994 peak discharge of about 107,000 ft³/s is the highest of record at Macon. Numerous changes in the floodplain and to the downstream river channel since 1948 have caused changes in the stage-discharge relation which resulted in the stage being higher for the 1990 flood than that of 1948, although the 1990 peak discharge was less than the peak discharge in 1948. The stage hydrograph (fig. 7) for Ocmulgee River at Macon shows that flood stages for the July 1994 flood exceeded the 100-year flood stage from about 1200 on July 6 to about 1200 on July 7.

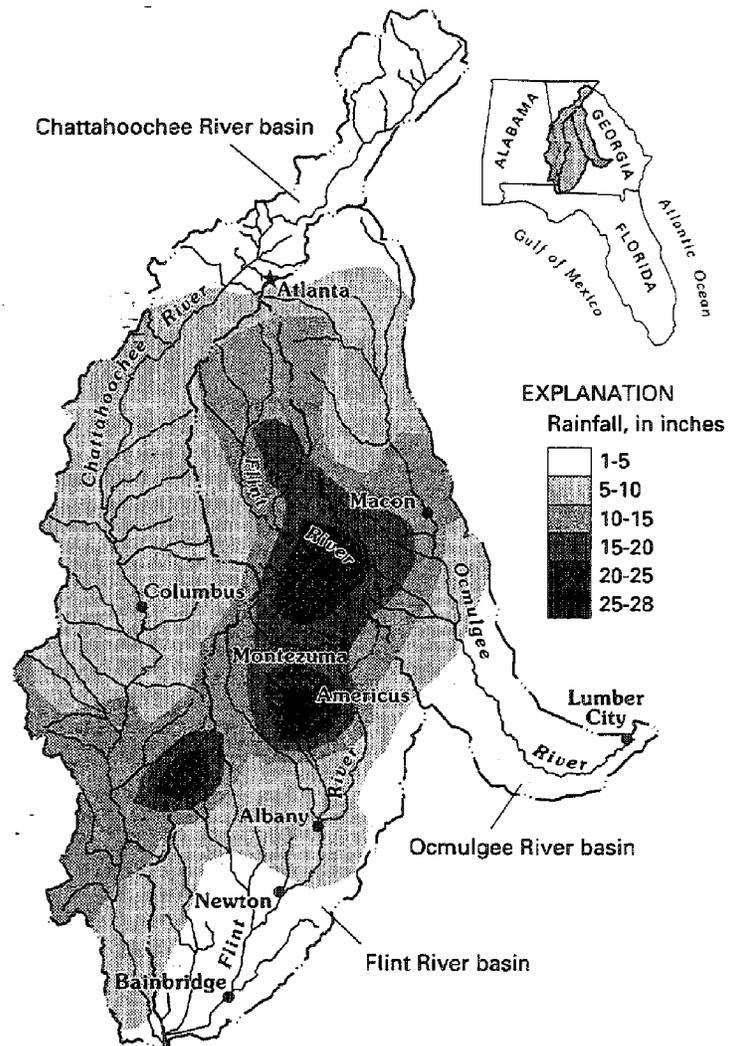
Figure 2. Storm-rainfall totals from Tropical Storm Alberto, July 3-7, 1994.

Storm-rainfall totals of over 13 inches (in.) commonly were recorded in the areas of the heaviest rainfall throughout central and southwestern Georgia (fig. 2). The highest total rainfall of 27.6 in. (July 3-7) and the highest 24-hour rainfall of 21.1 in. (24-hour period ending at 7 a.m. on July 6) were recorded in Americus. The rainfall for Americus was about 60 percent of the area's mean annual rainfall and the 24-hour rainfall was nearly 2.5 times greater than the area's estimated 100-year recurrence interval for 24-hour rainfall (National Weather Service, written commun., November 1994).

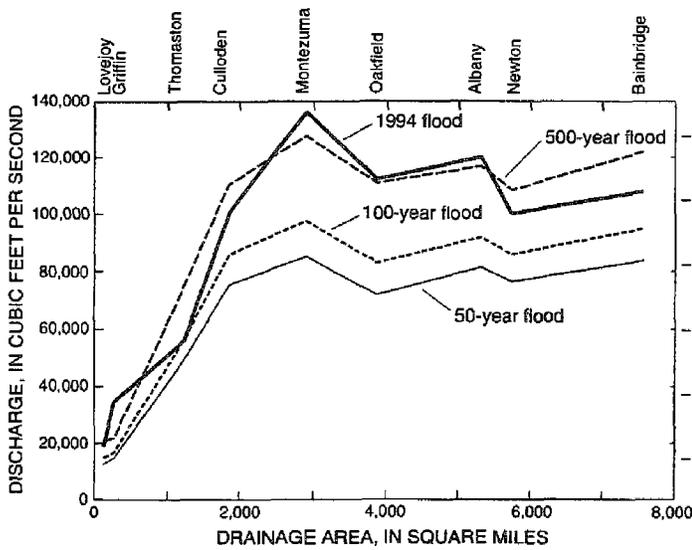
Figure 3. Selected recurrence-interval discharges for selected gaging stations in the Flint River basin.

Peak discharges greater than the 100-year flood discharge were recorded at Flint River gaging stations from Lovejoy, about 20 miles south of Atlanta to Bainbridge, to about 29 miles upstream of its confluence with the Chattahoochee River near the southwestern corner of the State (fig. 3). At Montezuma, the Flint River peaked on July 8 at a stage about 6.7 ft higher than the 1929 flood, which previously was the largest flood of this century at this gaging station. At Albany, the Flint River peaked on July 11 at a stage of about 43 ft, about 5 ft higher than the 1925 flood, which was the previous maximum flood. The stage hydrograph (fig. 4) for the July 1994 flood for the Flint River at Albany shows that floodwaters exceeded the 100-year stage from about 1300 hours on July 7 to 0600 hours on July 14.

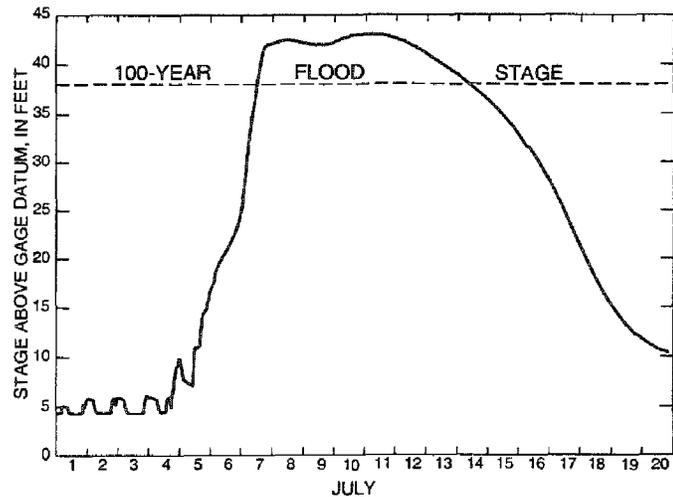
Figure 4. Stage hydrograph for Flint River at Albany, July 1994.

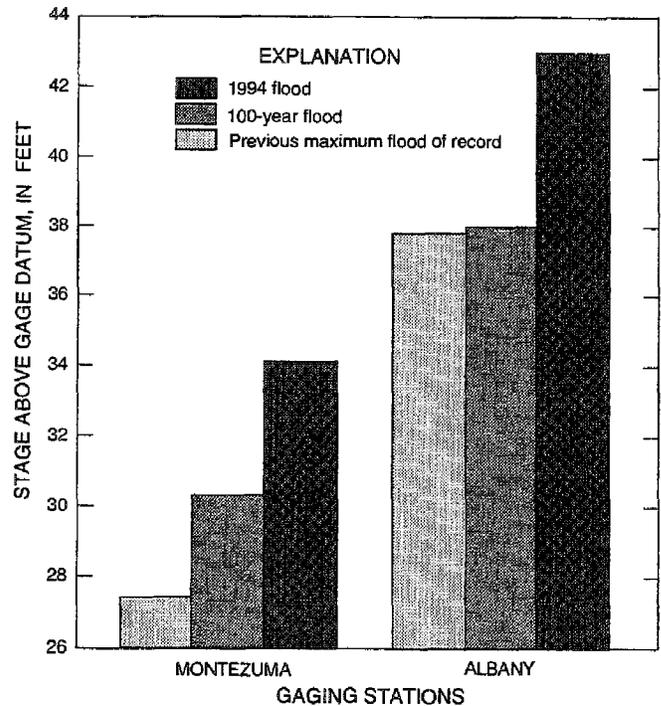
Figure 5. Flood stages for Flint River at Montezuma and Albany gaging stations.

A comparison of the July 1994 and the estimated 100-year flood stages (Stamey and Hess, 1993) for selected sites on the Flint River are shown in figure 5. At Montezuma, the July 1994 flood exceeded the estimated 100-year flood stage by about 3.7 ft and at Albany, by about 5.9 ft.

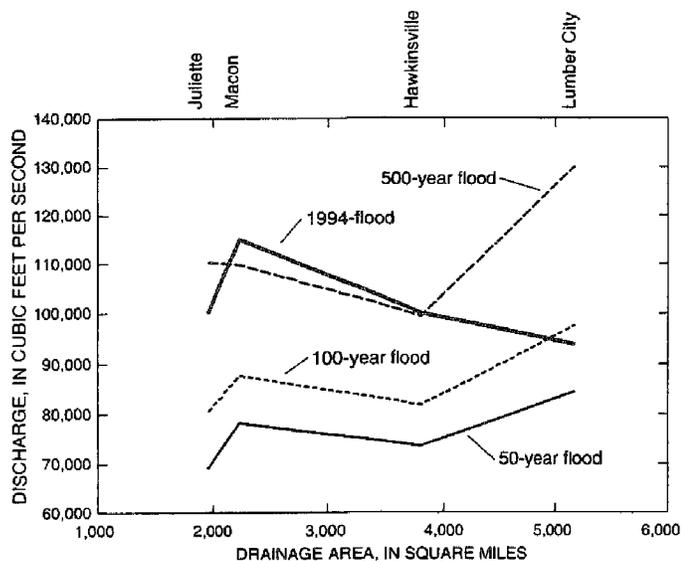
Figure 6. Selected recurrence-interval discharges at selected gaging stations in the Ocmulgee River basin.

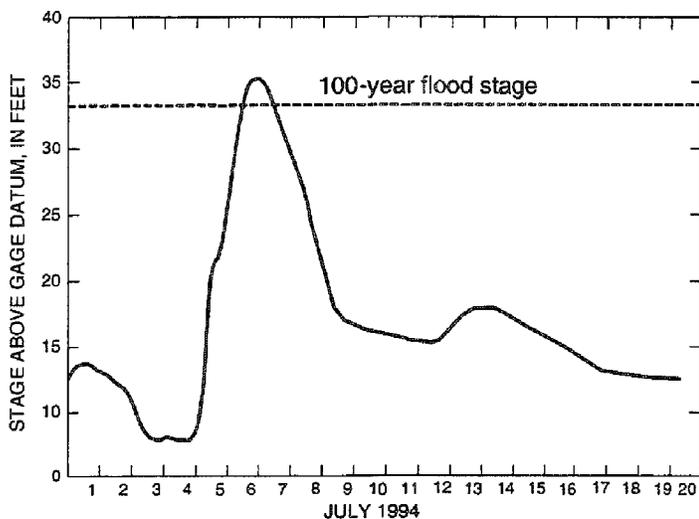
Figure 7. Stage hydrograph for Ocmulgee River at Macon, July 1994.
