EVALUATION OF A BTEX PLUME IN FRACTURED CRYSTALLINE ROCK IN THE GEORGIA PIEDMONT

James B. Feild¹ and John F. Dowd²

REFERENCE: *Proceedings of the 1999 Georgia Water Resources Conference*, held March 30-31, 1999, at the University of Georgia. Kathryn J. Hatcher, editor, Institute Ecology, The University of Georgia, Athens, Georgia.

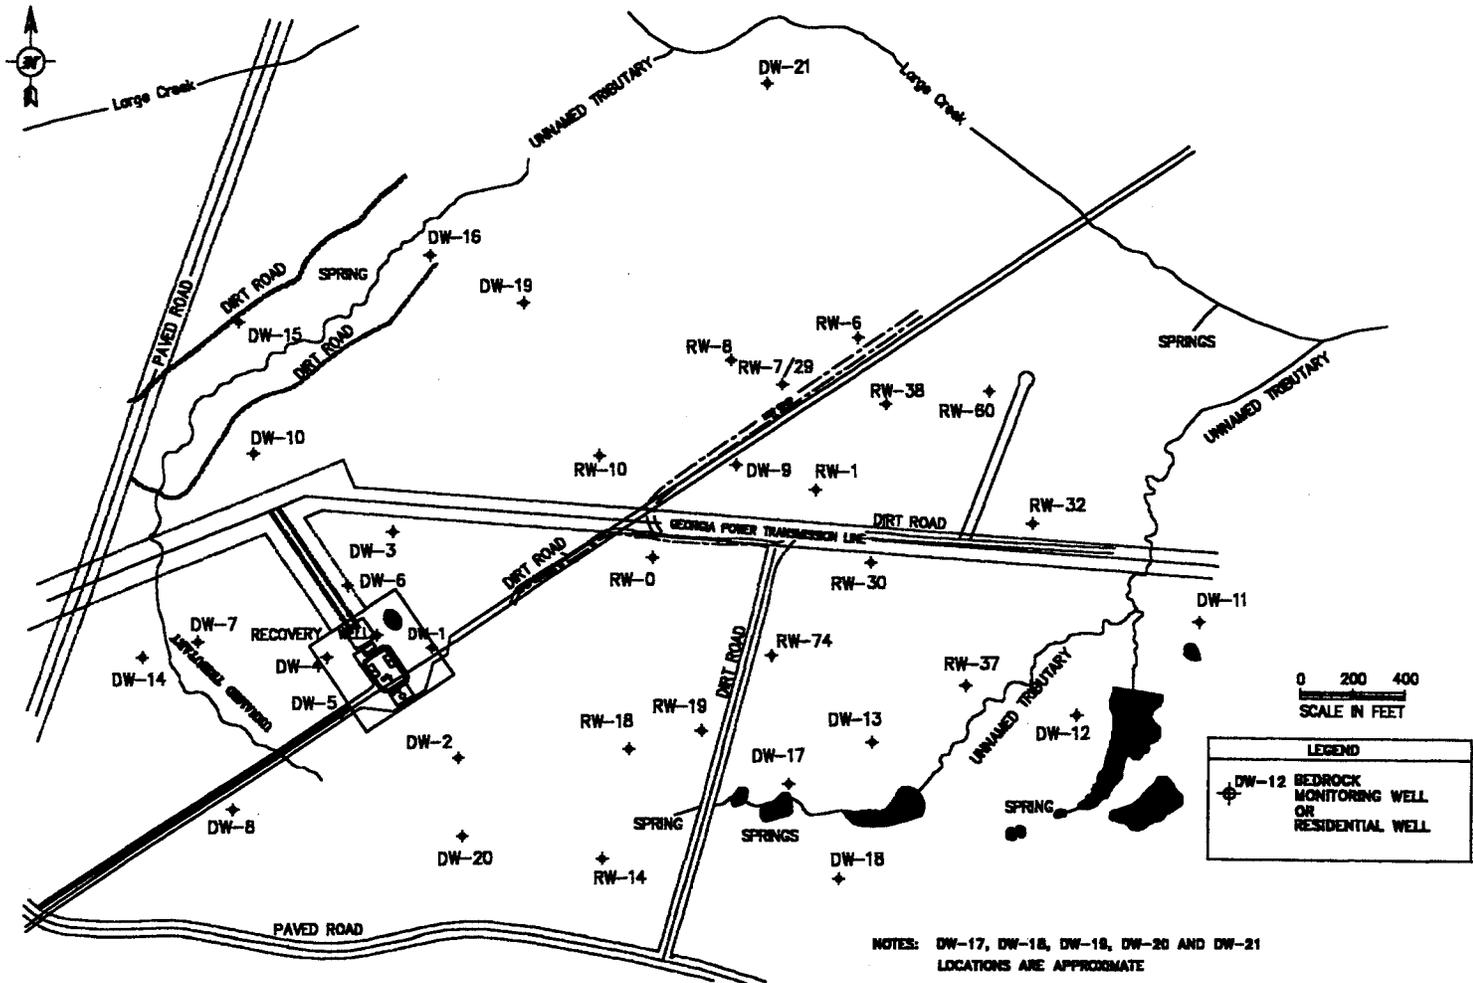
Figure 1 shows well locations at the site. Groundwater elevations and groundwater samples were collected from all applicable monitoring wells, both in the saprolite and the fractured bedrock. Samples were collected from the

Since the area of known spills coincides with the highest groundwater concentration of benzene (DW-4), then the conduit responsible for the contamination of the fractured bedrock aquifer must also be in that same general area (Figures 1 and 2). A water supply well provided the site buildings with potable water which was drawn from both the saprolite and the bedrock aquifers. The design of the well suggests that the well is not cased properly through the saprolite to the bedrock. This allowed the transport of contaminants from the saprolite to the fractured bedrock beneath the casing. Soon after the initial assessment, this potable bedrock supply well was converted to the existing recovery well for the remediation system.

Figure 1. Site Map showing locations of deep bedrock wells, residential wells, streams, ponds, roads, and power lines.
