Report on “Impact and Ballistic performance of monolithic Al-5083 Alloy and Al - SiC hollow sphere Composite”

For Deep Springs Technology, Inc.

Prepared by: Greg Kennedy, Ricky Whelchel, Paul Specht, Tom Sanders, Joe Cochran, and Naresh Thadhani; High-Strain-Rate Research Group, MSE, Georgia Tech

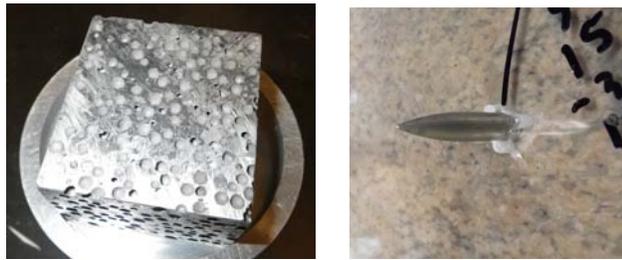
Figure 4. Composite slab mounted on Al sabot (left) and 7.62 mm steel bullet mounted on PMMA plate (right)

A reverse ballistics experiment was performed on Al-5083 alloy containing SiC hollow spheres provided by Deep Springs. The Al-SiC hollow sphere composite available in the form of a 27-mm thick section was affixed to the front of a 127 mm long, 80 mm diameter aluminum sabot for reverse ballistic testing at 660 m/s. The Al sabot was machined with a 8-mm wide step and 28-mm deep pocket such that the diagonal edges of the composite slab (shown in Figure 4 (a)) rest on the step and maintain an air gap to allow free-travel of projectile in to the Al sabot witness material, in case of penetration through the composite. Figure 4(b) shows the steel bullet shaped target of 7.62mm diameter and 31.78 mm length held in the center of the gun axis by a 6 mm piece of PMMA.

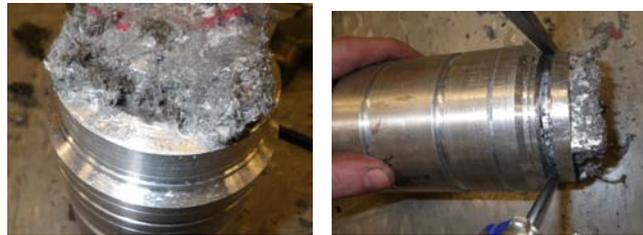
Figure 5. Images of recovered debris following reverse ballistic experiment at 660 m/s.

Following impact, the sabot and composite material were soft recovered in a catch tank of packed rags, some of which stuck to the surface. The front of the aluminum sabot was removed by turning on a lathe and the sample was extracted. Figure 5 shows images of the recovered debris following the experiment. The front of Aluminum sabot was removed by turning on a lathe and the sample was extracted.

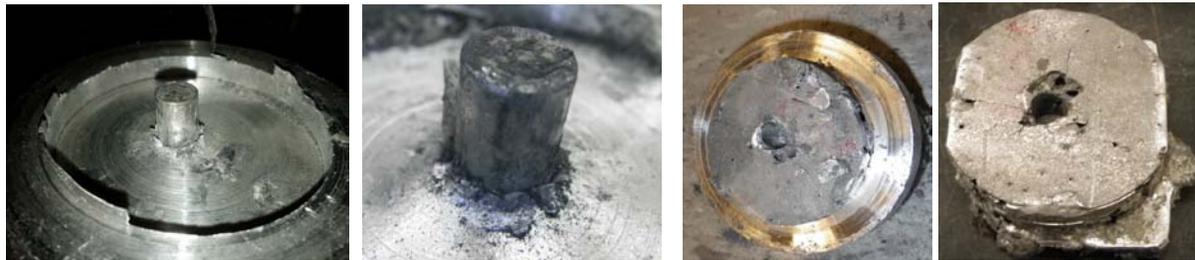
Figure 6. Images of recovered composite and sabot materials following reverse ballistic experiment at 660 m/s, showing clean penetration of the steel bullet through the Al-SiC composite, and the travel of the bullet into the backing sabot material.

As illustrated in Figure 6, the Al-SiC composite rear surface (far right image) did not show evidence of impacting the bottom of the pocket in the aluminum sabot. The steel bullet was captured in the aluminum sabot after it completely penetrated through the 28-mm thick Al-SiC hollow-sphere composite slab and into the backing Al to a depth of 20-mm. The rear (Al-side) surface of the composite shows some radial cracking and some material removed near the hole, but no evidence of the composite material (spheres or Al matrix) impacting the sabot material.
